NUCLEAR WEAPONS EFFECTS TESTS  
OF BLAST TYPE SHELTERS

A Documentary Compendium of Test Reports

# **NUCLEAR WEAPONS EFFECTS TESTS OF BLAST TYPE SHELTERS**

**A Documentary Compendium of Test Reports**

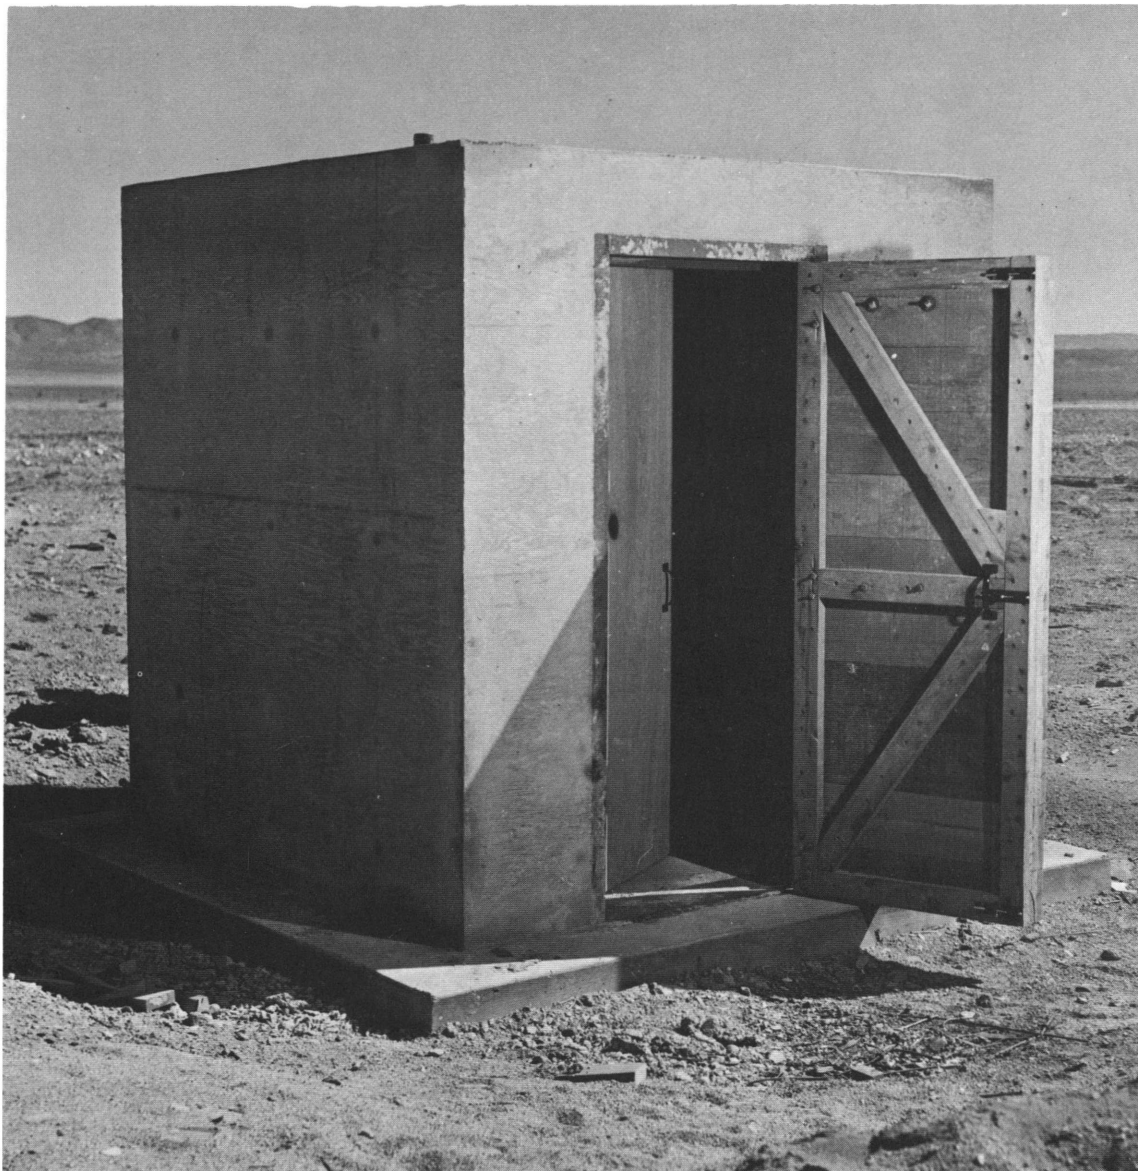
UTILITY-TYPE SHELTERS. *Shot Apple II (Stations 1–34.1 e,f,g at 2250 ft)*. The masonry shelter disintegrated. The poured-in-place reinforced-concrete shelter remained intact. It was displaced and came to rest on its side 50 ft from its original position. The precast reinforced-concrete shelter failed severely. Door fastenings failed on the poured-in-place structure, and the doors on the precast shelter blew away.

Fig. 20—Exterior of reinforced-concrete utility-type shelter, stations 1–34.1 f, i, and l.

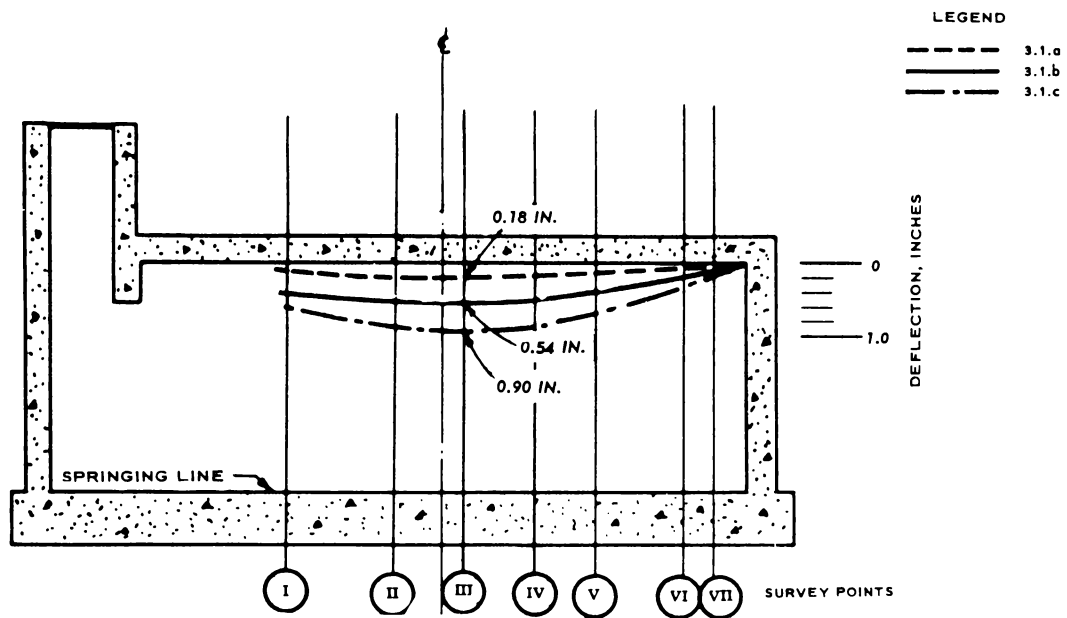
Fig. 7—Permanent crown deflection with respect to the spring line of the arch, structures 3.1a, b, and c.

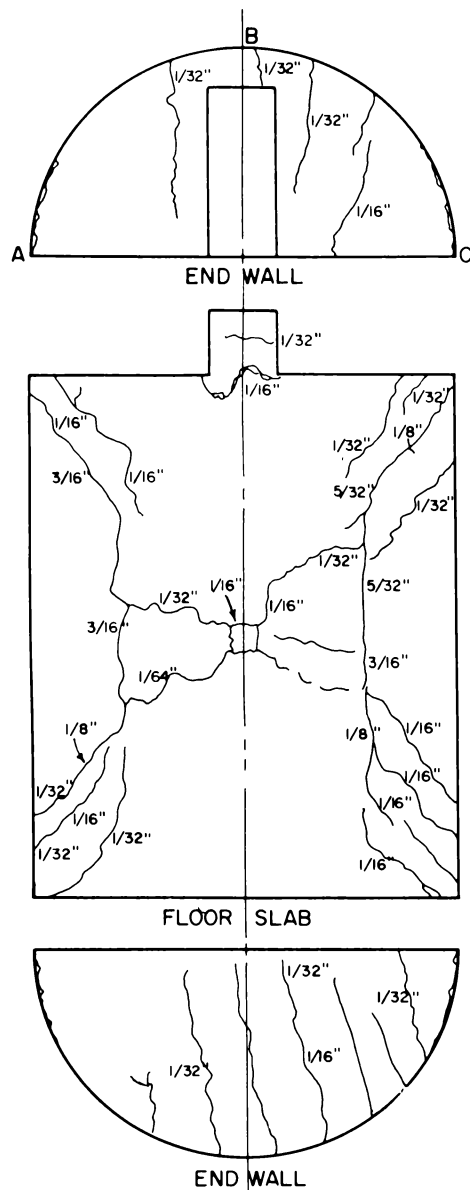
NOTE: All Crack Widths Not Noted Are Less Than  $\frac{1}{64}$  Inch Wide.

Fig. 10—Postshot crack survey, structure 3.1c.

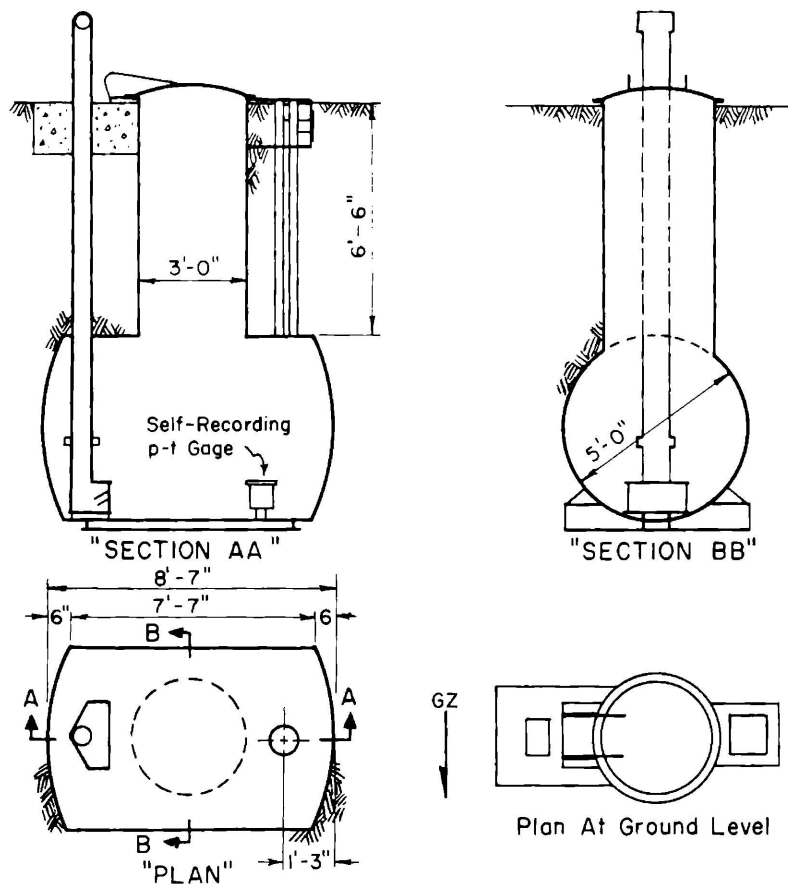
In this project, to avoid possible failure of the other tests in the structure if the valve malfunctioned, the ventilating ducts were sealed. The valve was attached to a separate plenum (Figs. 9 and 10). This valve, developed by the Army Chemical Center, was rated at 600 cfm. The test plenum contained approximately 215 cu ft, or far less than the shelter proper; this would affect the interpretation of the results. Had the chamber in which the valve was located been larger, the pressure rise would have been less.

Fig. 9—Pressure plenum for blast closure valve test.

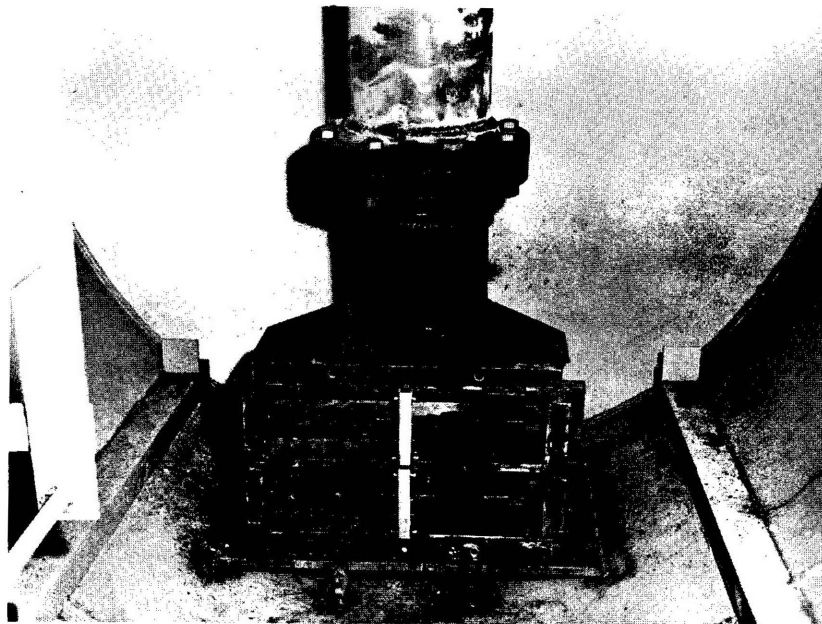
Fig. 10—Blast closure valve installed in test plenum.

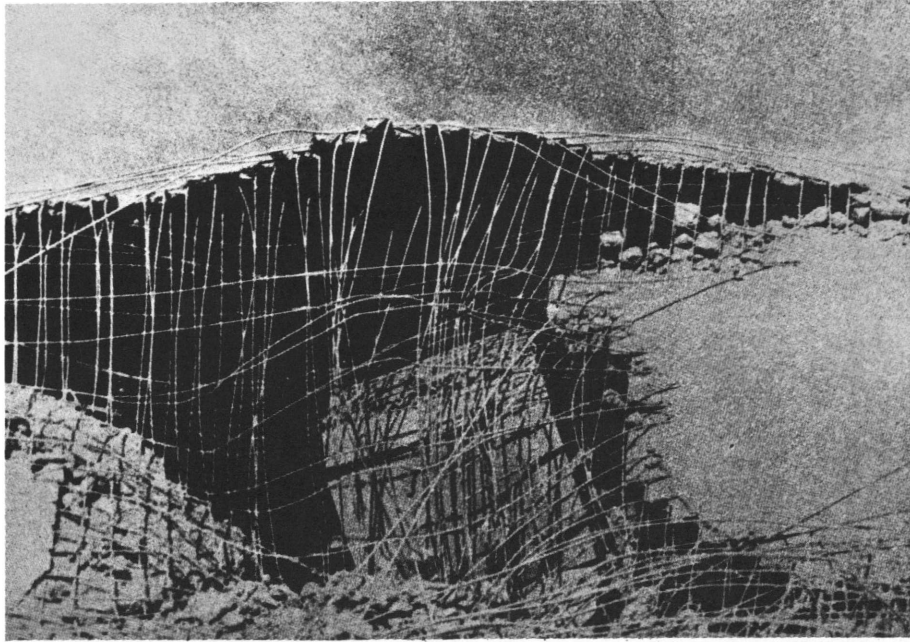
The responding concrete domes suffered various degrees of damage, depending on the pressure range. The dome in the high-pressure region suffered, essentially, total destruction (Fig. 13); the dome in the medium-pressure region was severely damaged (Fig. 14); and the dome in the low-pressure (20-psi) region was undamaged. The steel reinforcing rods from the destroyed regions of both damaged domes were stripped of practically all concrete (Fig. 15), which was remarkable because concrete bonds itself very well to steel. Foundations of all three domes survived without damage, and access doors showed no effects.

Fig. 15—Responding concrete dome at 35-psi overpressure region.

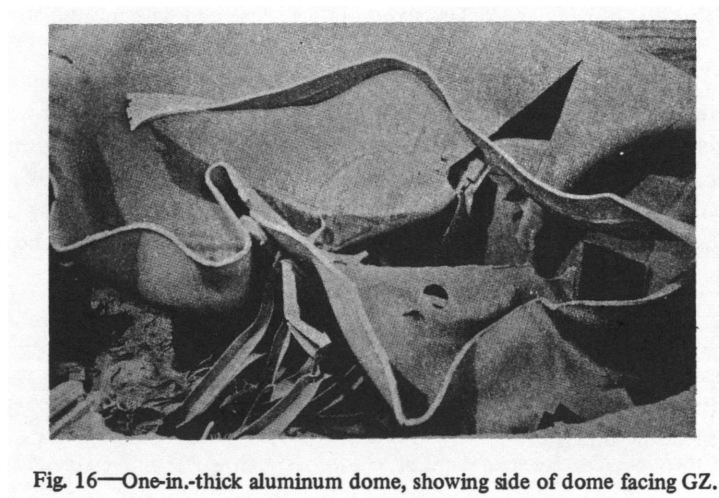
Both responding aluminum domes were completely destroyed. The  $\frac{1}{2}$ -in.-thick dome was dished down into the foundation. The 1-in.-thick shell was crushed against the side of the foundation away from GZ (Fig. 16).

Fig. 16—One-in.-thick aluminum dome, showing side of dome facing GZ.

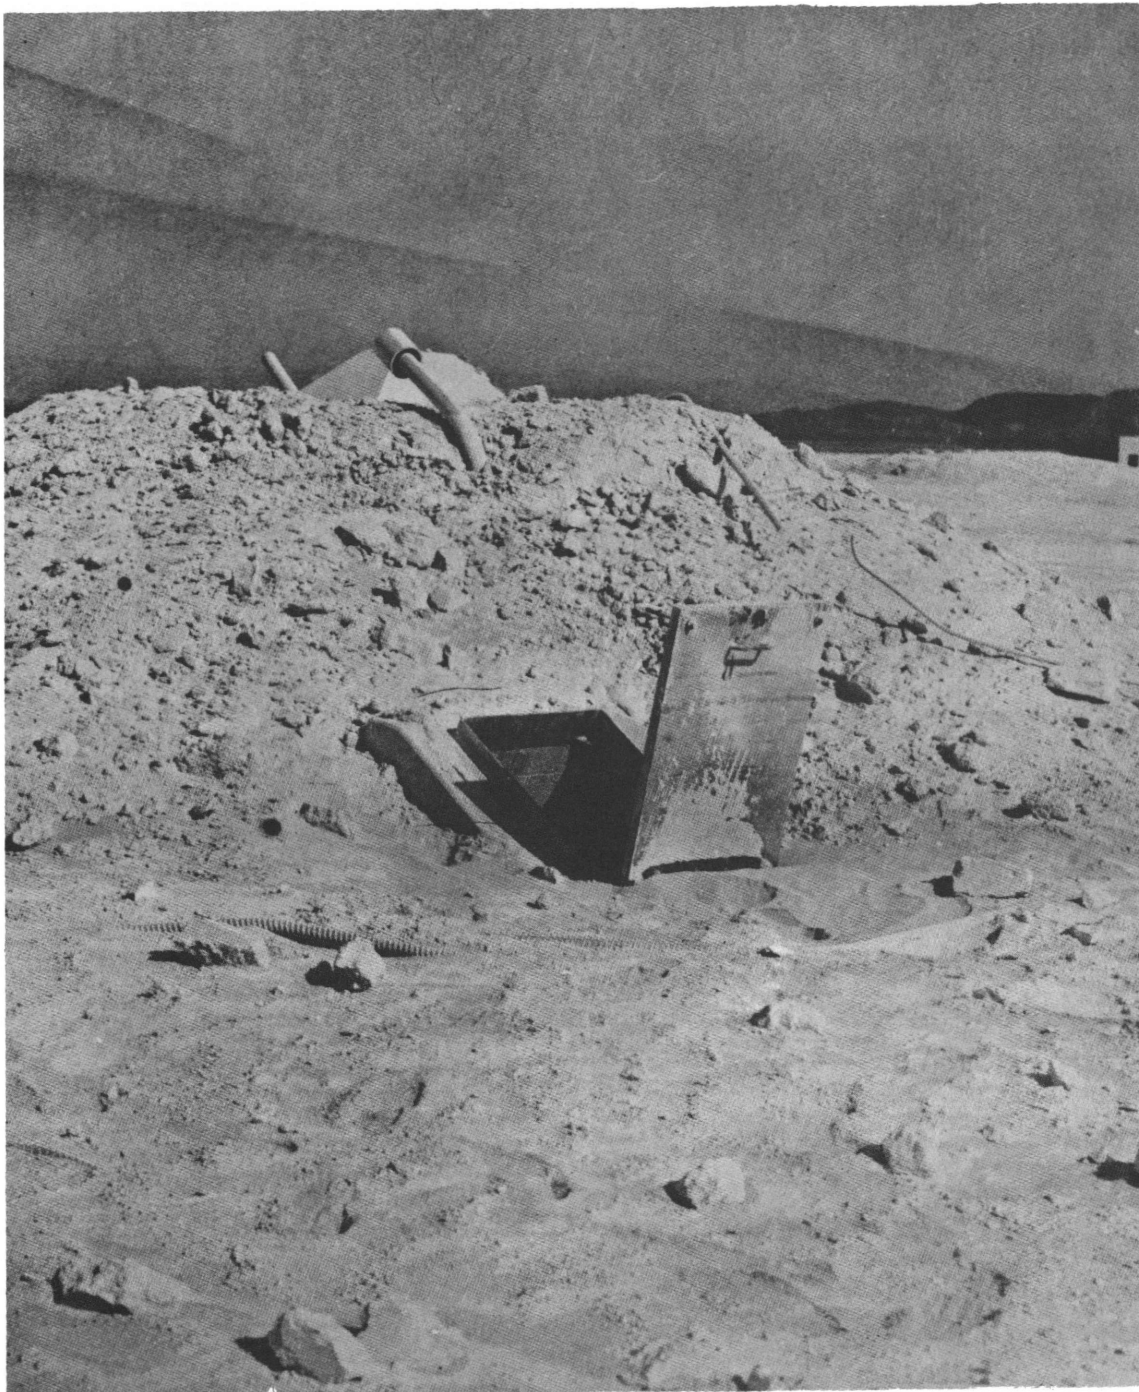
The family shelter would probably sustain peak incident overpressures appreciably greater than 65 psi. The usefulness of the ventilation system was virtually ended by its blast damage.

Fig. 7—Family-shelter ventilators bent over by blast.

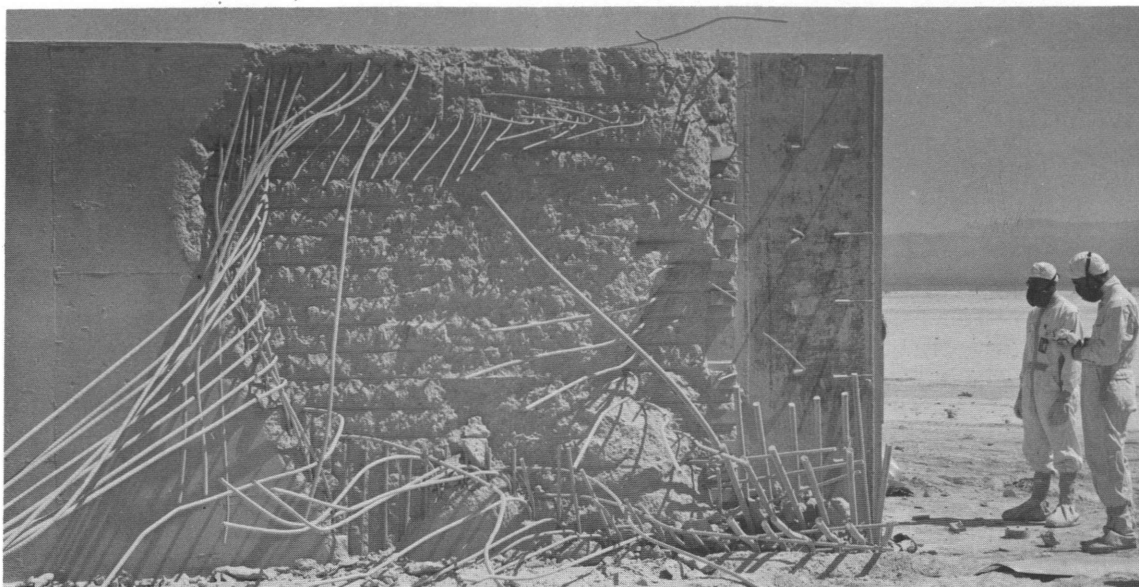
Fig. 2—South face of vault, postshot.

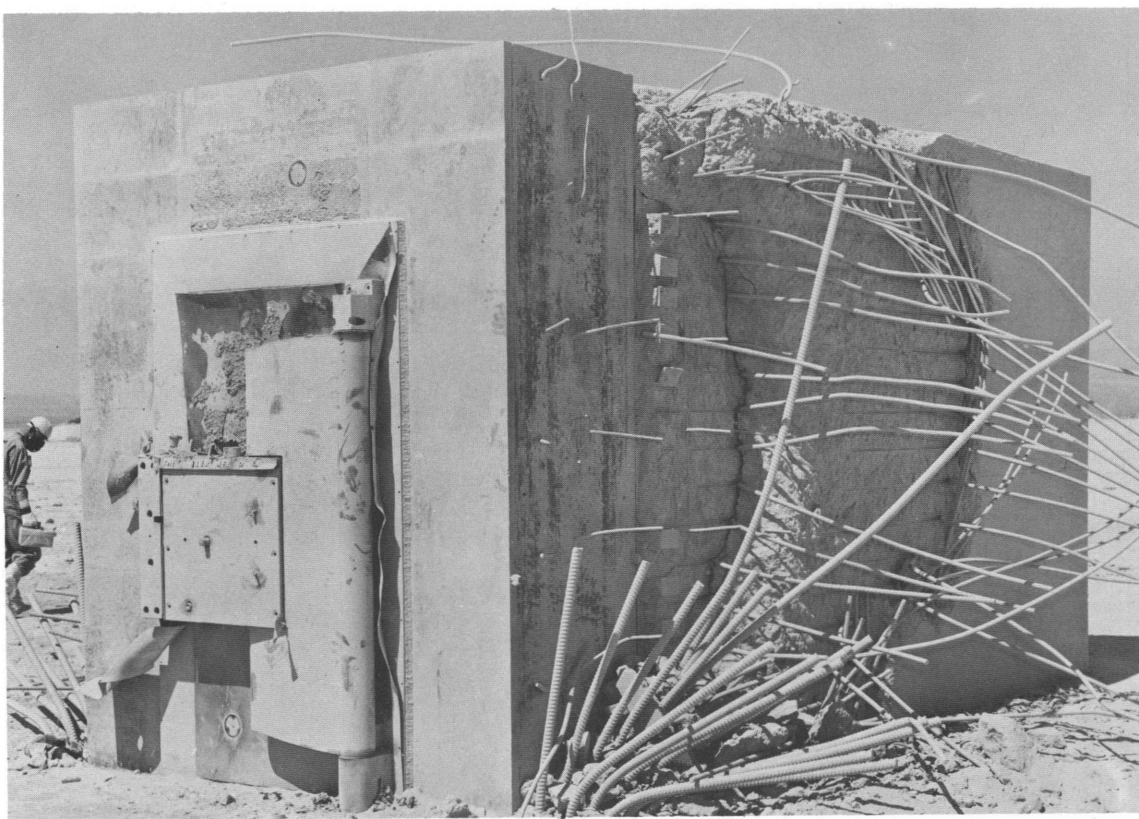
Fig. 3—Front and north faces of vault, postshot.

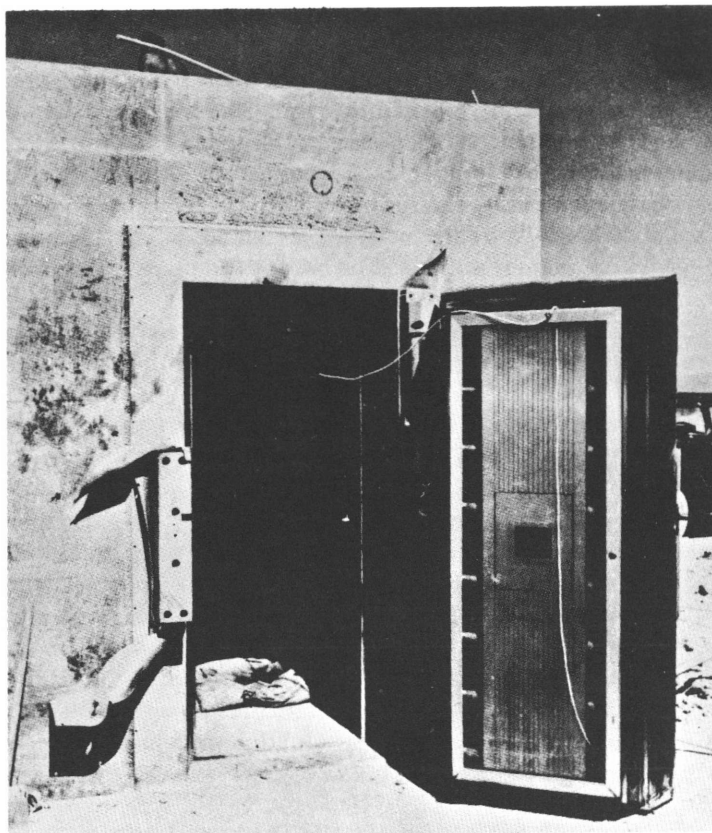
Fig. 8—Front face of vault, door open, postshot.

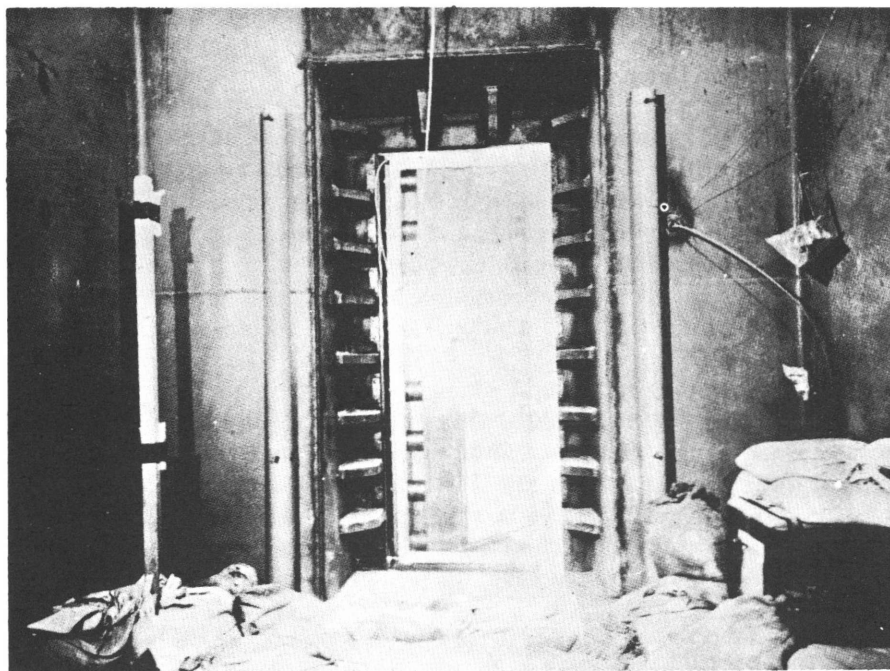
Fig. 9—Interior view looking toward door, postshot.

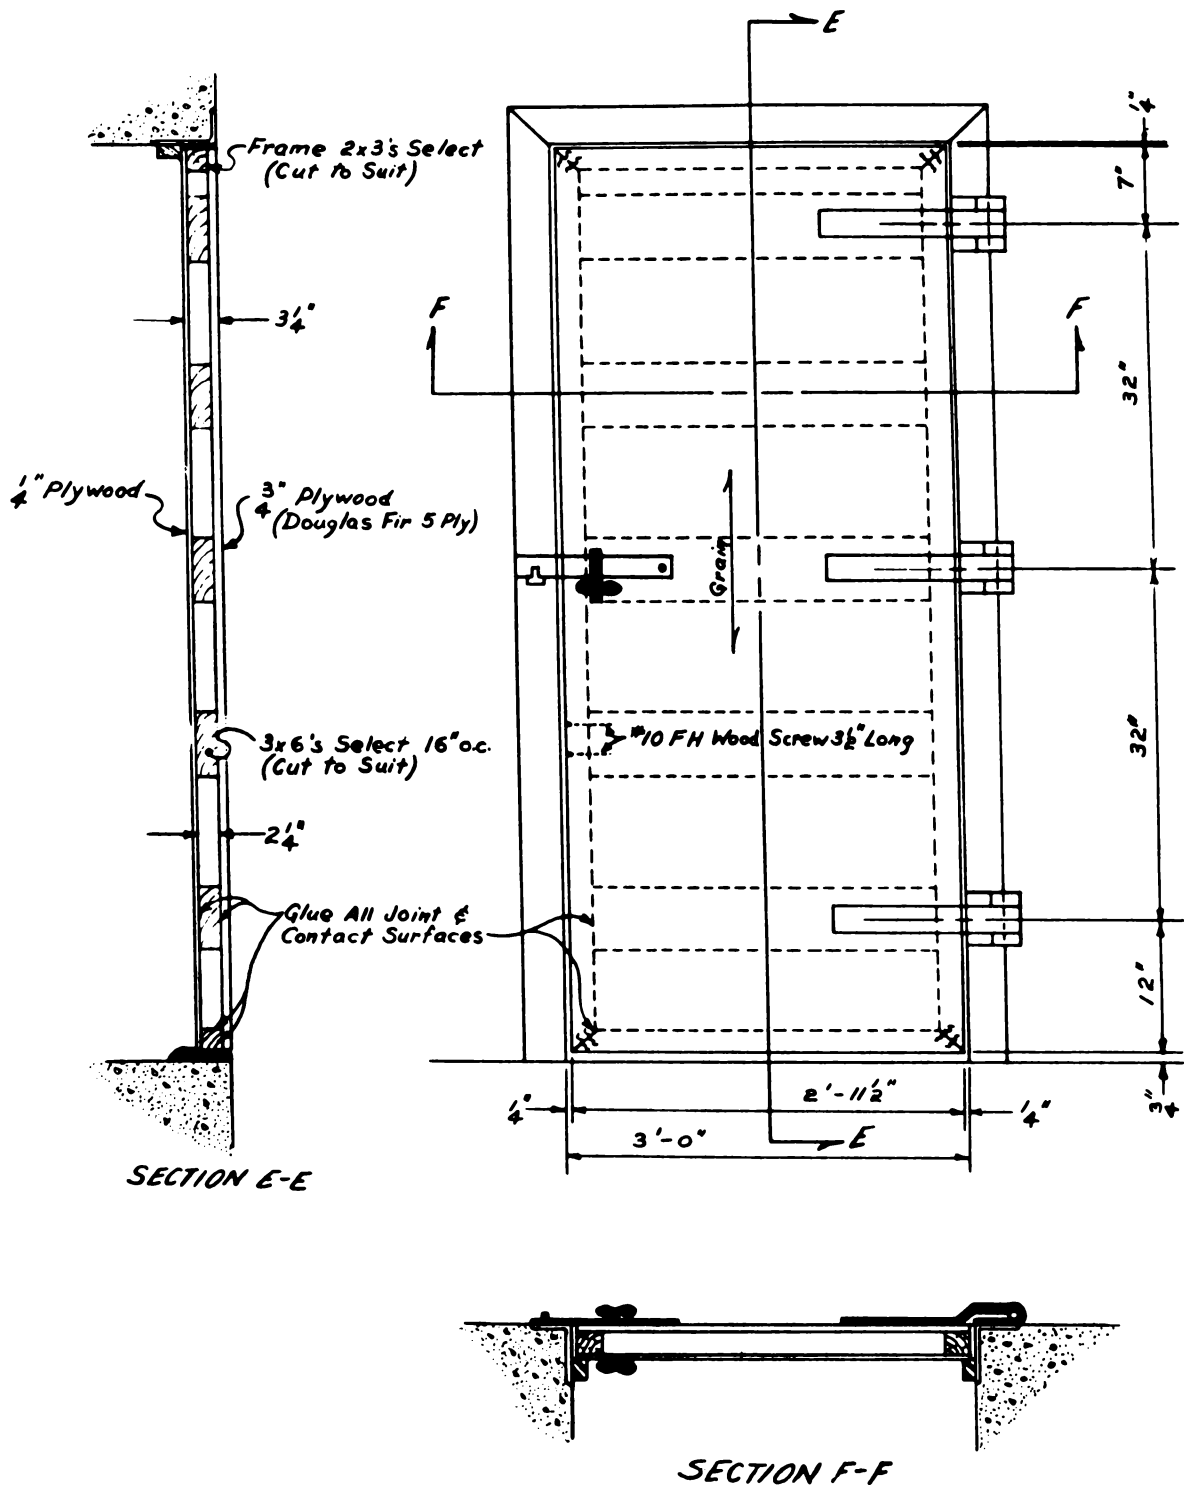
A summary of test results is given in Table 1. The peak reflected overpressures were slightly greater than design assumptions. The only door that failed structurally was the hollow-plywood door at the high blast range. Other permanent damage was limited to charring of paint on the wooden doors.

Fig. 6—Hollow-plywood door detail.

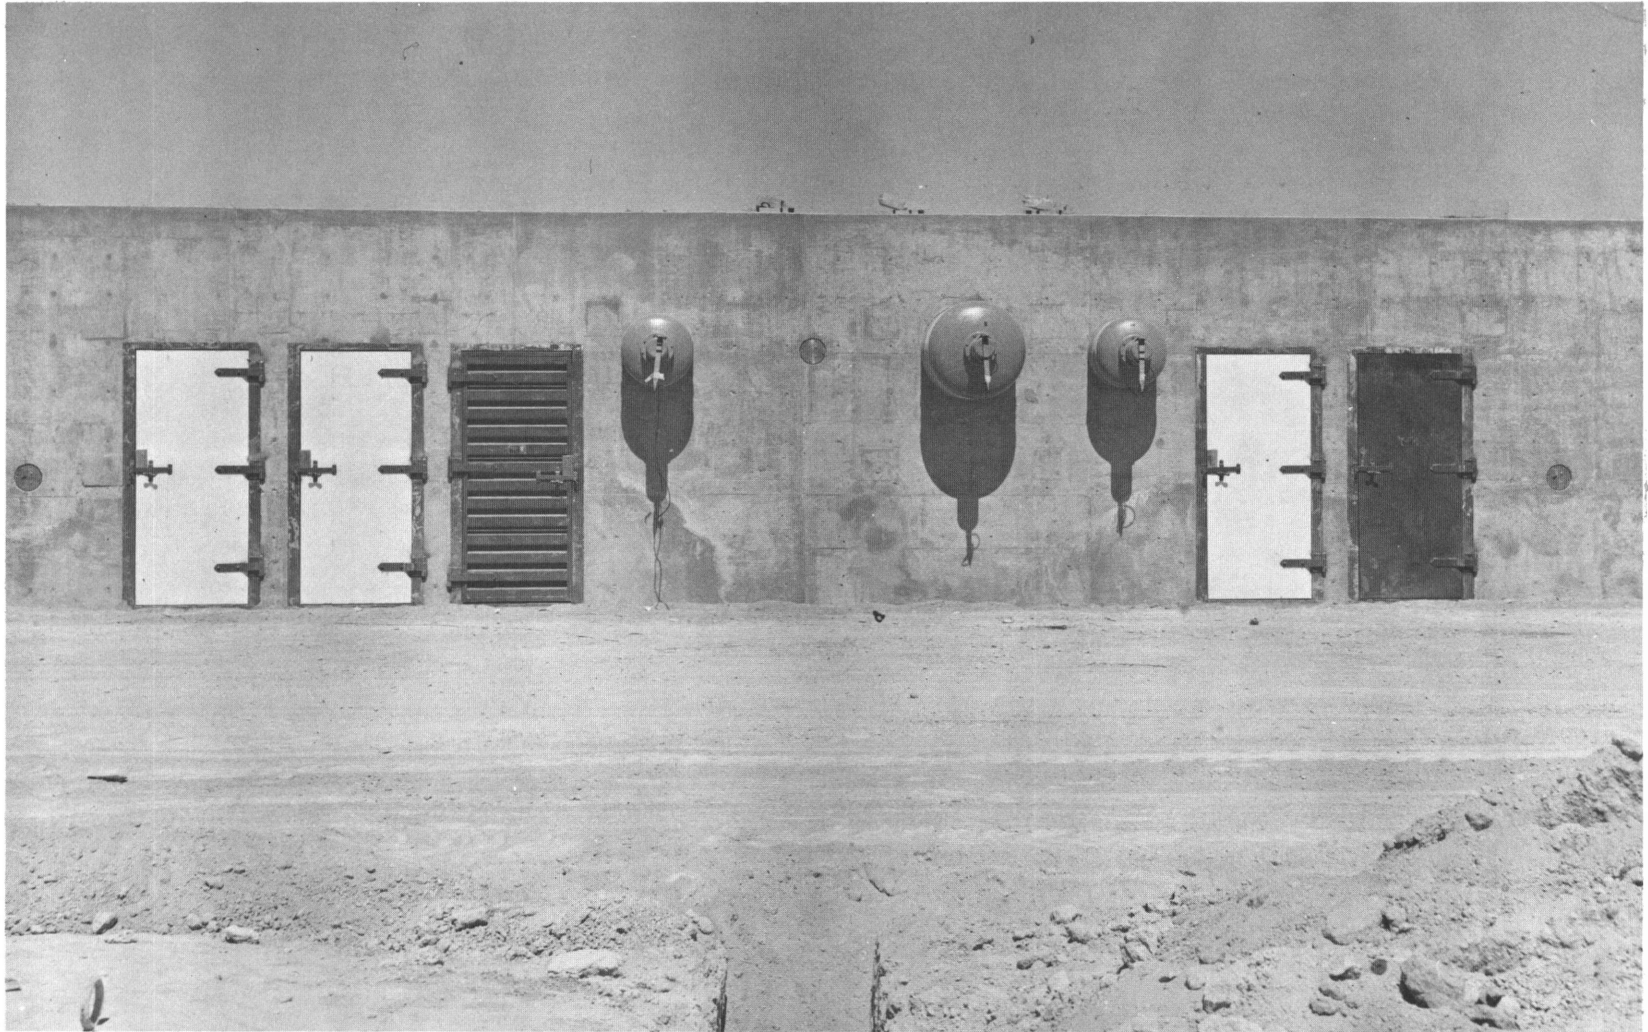
Fig. 8—Typical cell closures. Doors, from left: solid plywood, wood plank, cellular steel, hollow plywood, and steel plate.

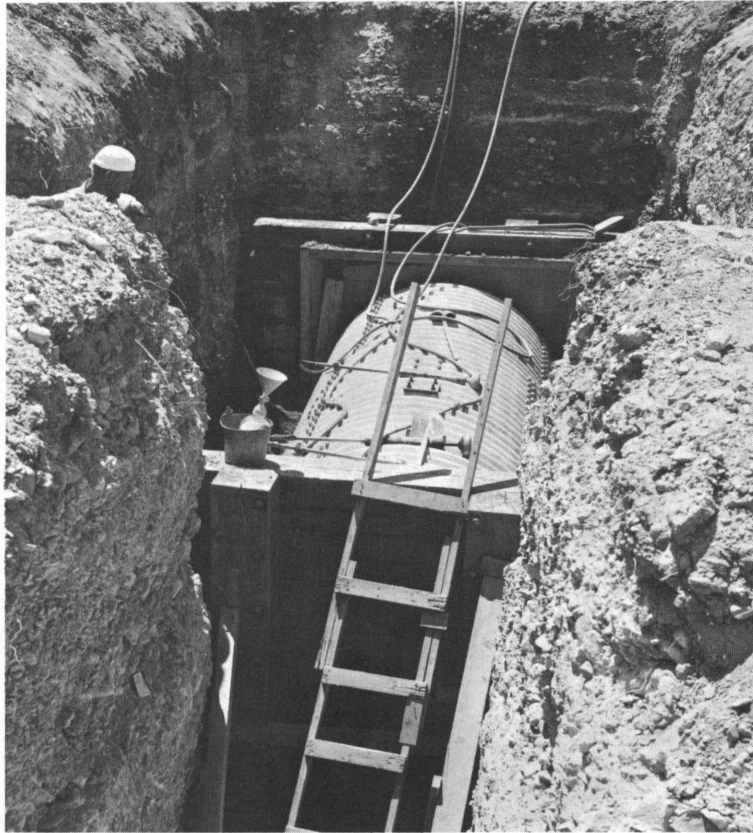
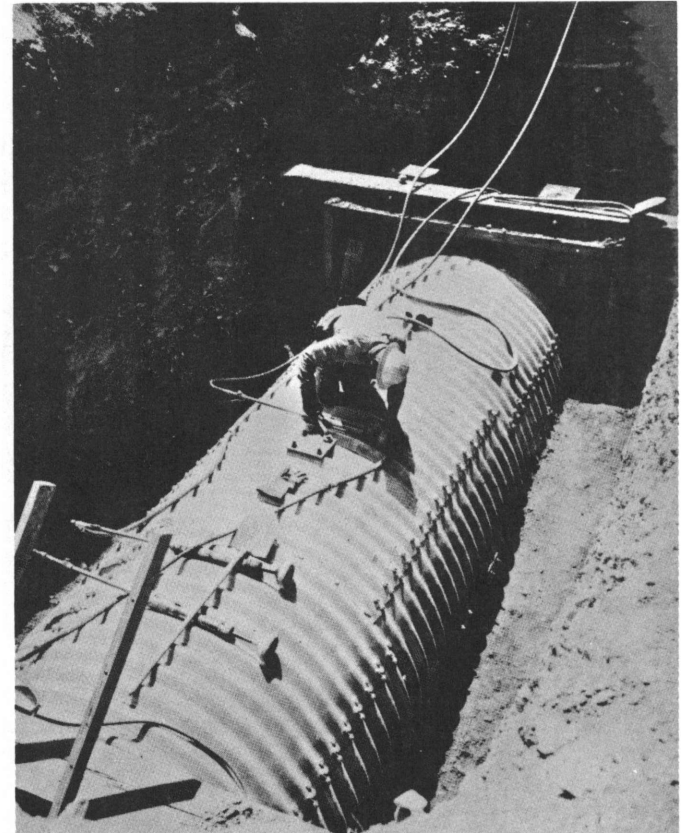
Fig. 3—Exterior views of pipe in place before placing backfill.

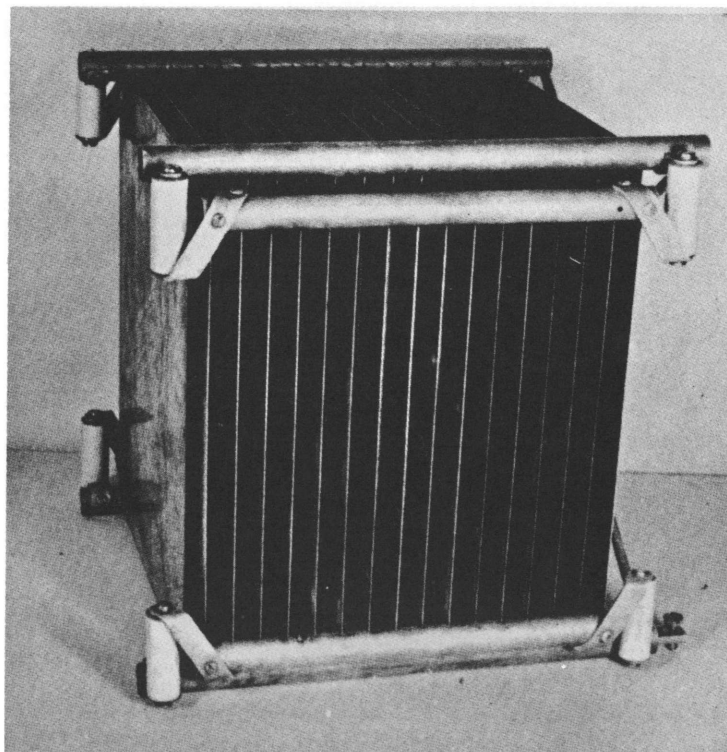
Inspection of the electrostatic-precipitator unit in hood 6 indicated negligible removal of dust from the lubricated plates and nearly complete removal from the dry plates.

6. Reentrainment of dust from dry electrostatic-precipitator plates in the 1.9-psig area was high, showing greater than 90% loss.

Fig. 9—Electrostatic-precipitator collecting stage.

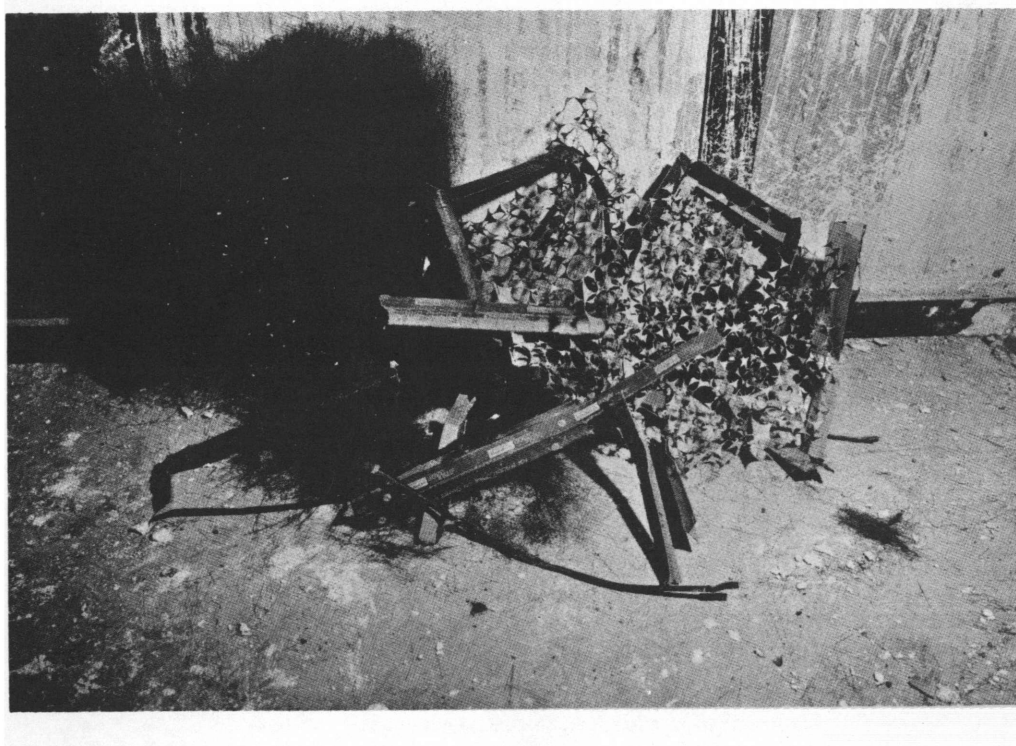
**Exhaust Ventilation and Air-cleaning Equipment**—No visible signs of damage or displacement of steel and wood duct systems were detected. Preliminary inspection of AEC filters and the Far-Air unit showed no visible signs of damage. Dust-Stop prefilters in hoods 1 and 3 (Fig. 10) were intact with but a slight bowing-out of the center metal supporting strip. The Dust-Stop filter located in the supply-air opening in the entrance door and subjected to side-on pressure was completely destroyed (Fig. 11).

Fig. 11—Dust-Stop filter debris in chemical plant, postshot.

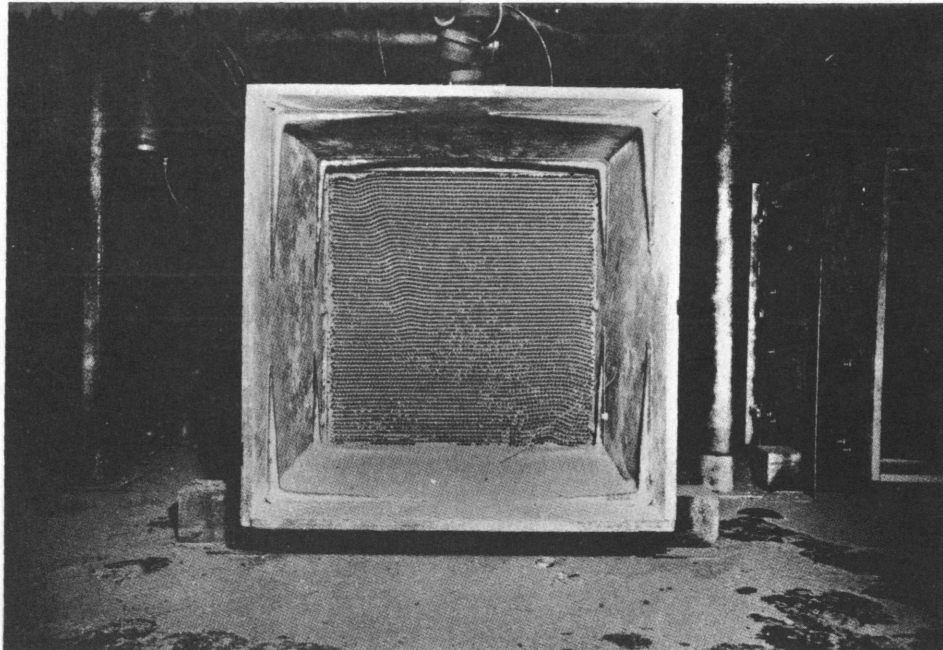
9. Large percentages of the dust dislodged from AEC filters were deposited in the hoods immediately in front of the filters. Observed values were 26 and 40% in the 4.0- and 1.9-psig areas, respectively.

Fig. 12—Dust loss from 12-in. AEC filter in hood 4 in chemical plant, postshot.

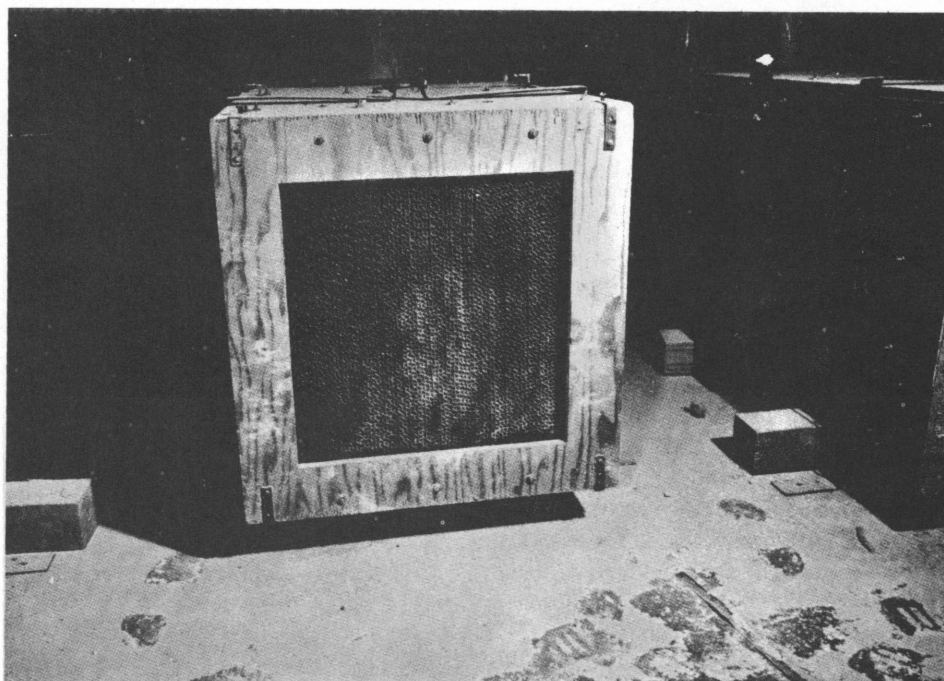
Fig. 13—Far-Air filter in hood 2 in chemical plant, postshot.

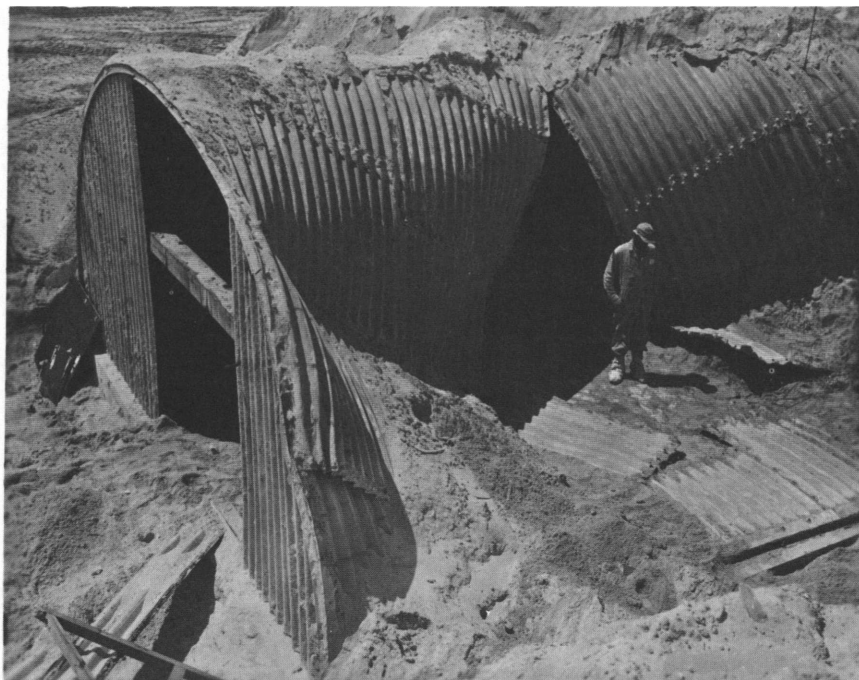
1. An extensive transverse rupture at a bolted seam of the arch shell (Fig. 10) had occurred 8 ft rearward of the midlength (midpoint) and 16 ft forward of the rear end wall. This rupture extended from the floor, on the side away from Ground Zero (GZ), vertically to a point that had originally been 3 ft from the arch crown on the GZ side.

Fig. 10—Structure 3.2a, postshot, showing deformed section of structure on side away from GZ after excavation for examination. End-wall sections had been removed so that sand could be removed from within the structure more easily.

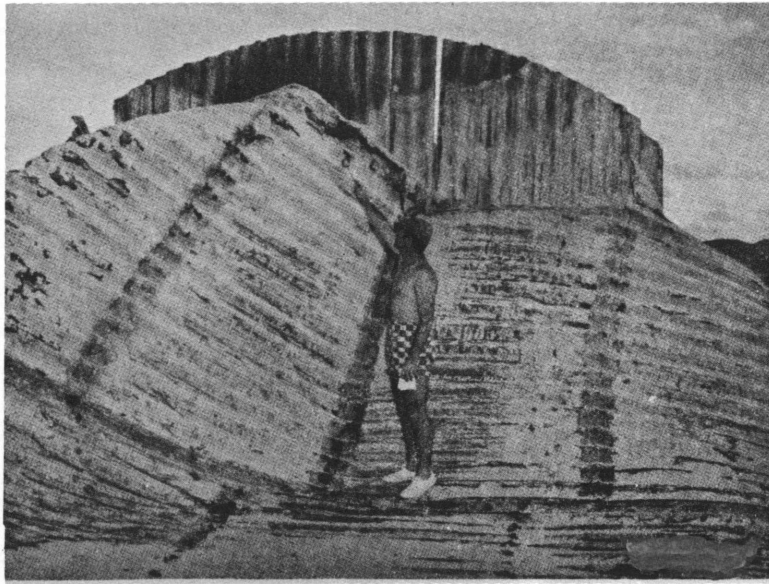
Fig. 12—Structure 3.2b, position of original crown of arch shell after collapse; end wall remained upright; GZ to left.

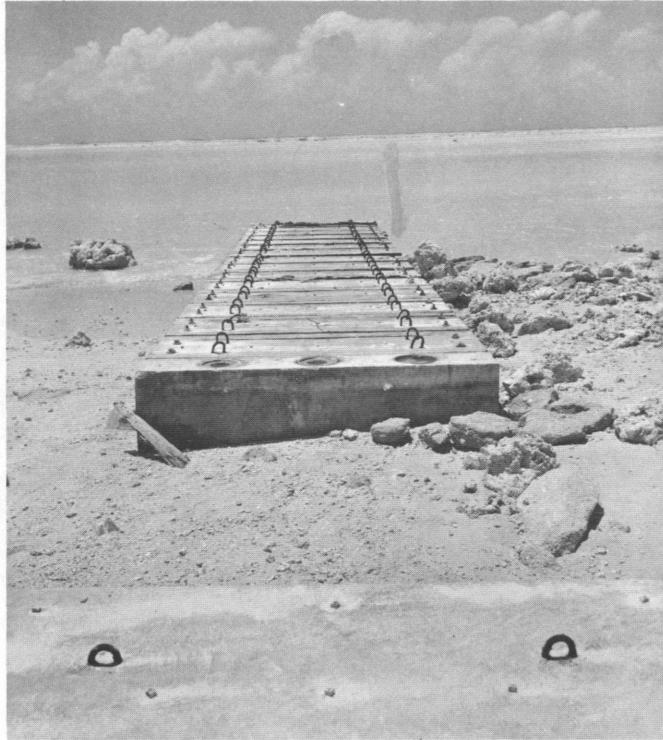
**Fig. 7—Posttest view of one-way slabs at station 360.01, range 1830 ft. Ground Zero is to the left.**

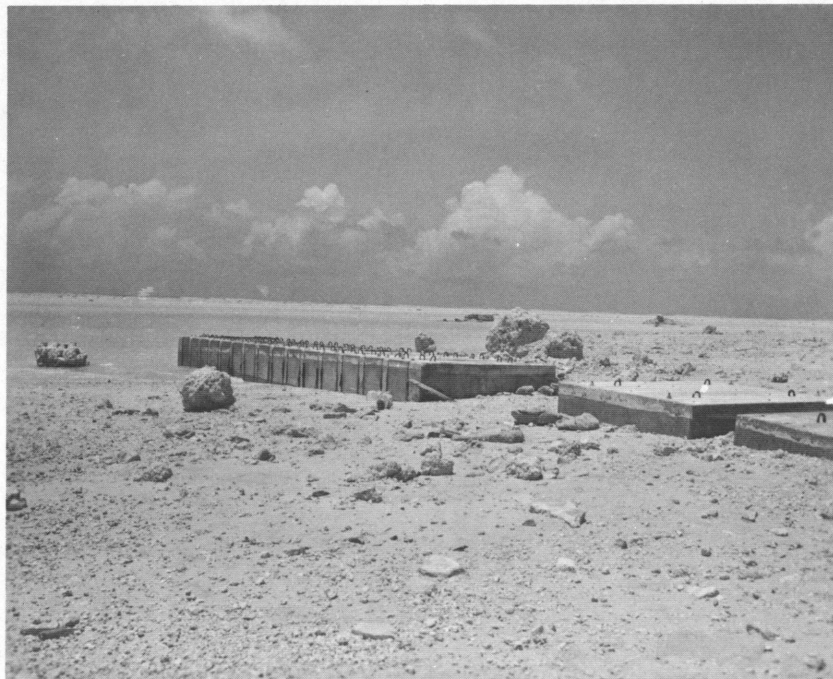
**Fig. 8—Posttest view of one-way slabs at station 360.01, range 1830 ft, looking at GZ side of slabs.**

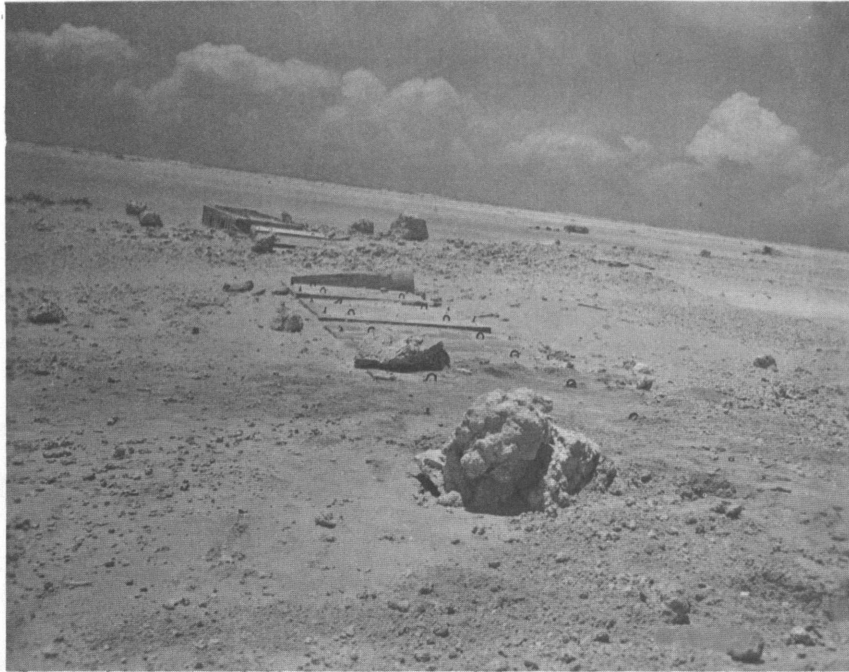
**Fig. 9—Posttest overall view of slabs at station 360.01, range 1830 ft. Note edge of crater adjacent to one-way slabs in rear. Ground Zero is to the left.**

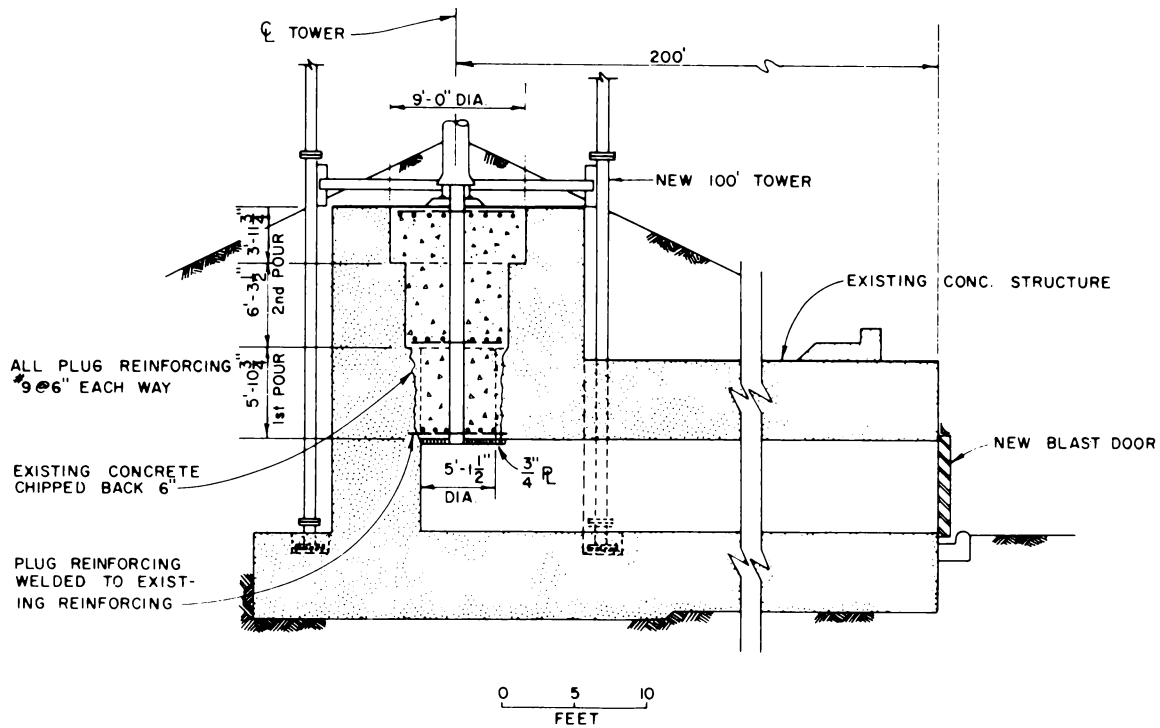
Fig. 3—Section through new concrete plug.

The explosion demolished the concrete plug as well as much of the surrounding base and caused failure of the blast door. Lack of dynamic shear strength in the young concrete was a possible factor in plug failure. The instrument sled could not be recovered because large amounts of debris blocked its removal. Although the fireball just touched the surface of the base, a conspicuous jet preceded it down the tower pipe. Thermal radiation was estimated to be  $320 \text{ cal/cm}^2$  at the surface of the plug.

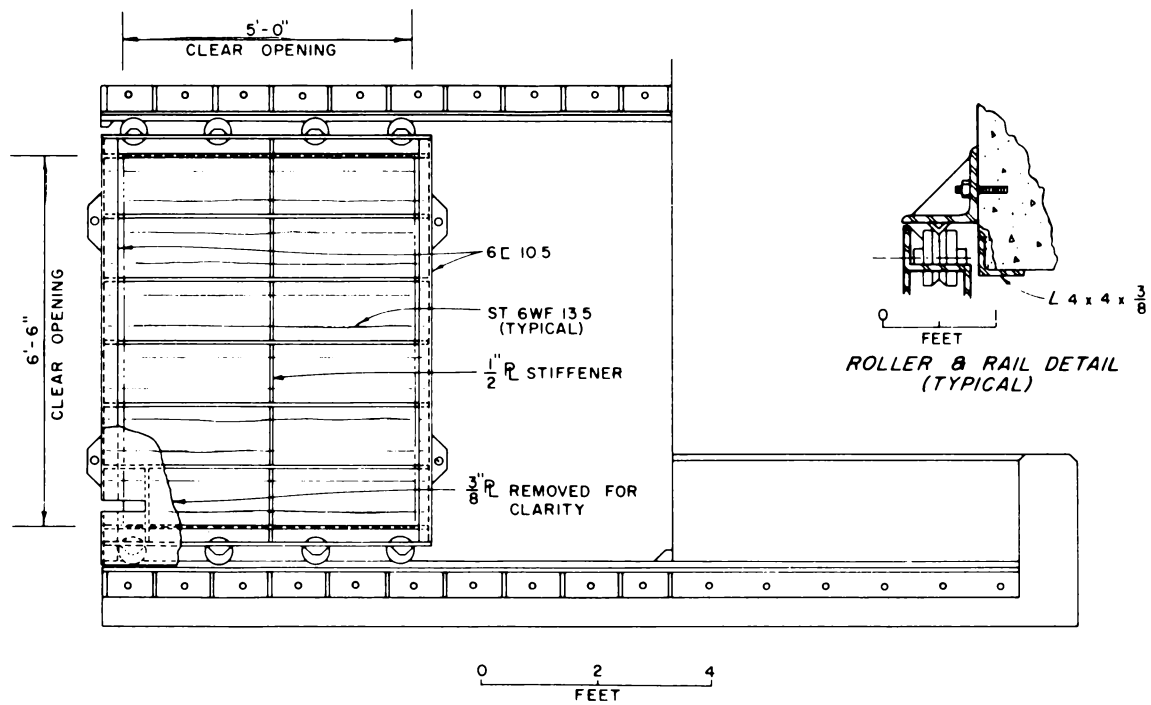
Fig. 4—Exterior elevation of blast door.

The blast door covering the entrance of the tunnel was blown outward and came to rest about 66 ft from its installed position. Although this door was not extensively damaged, there was a slight horizontal bend across its center. Failure of the blast door was probably caused by reflected pressure acting on the inside of the door as a result of failure of the plug.

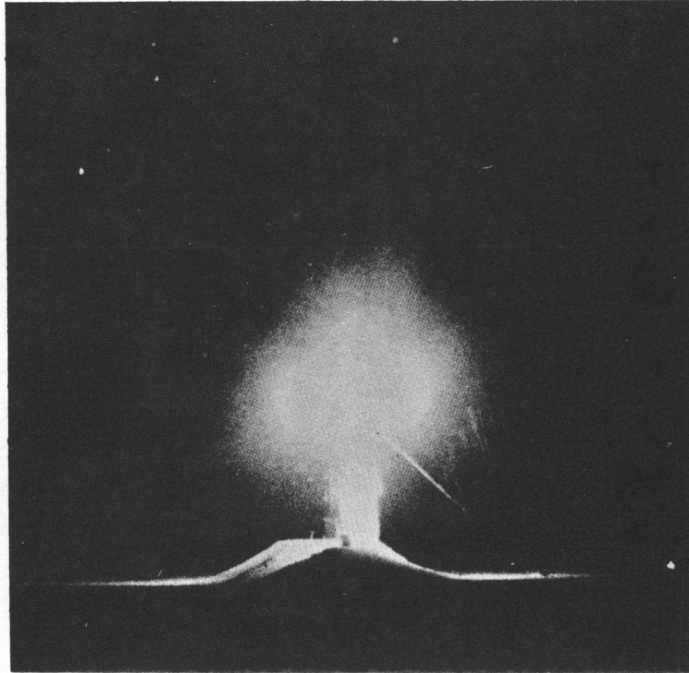
Fig. 6—Quay event fireball.

\*Computed by assuming a spherical shock front emanating from a spherical source of energy. Jetting (Fig. 6) probably caused much higher local pressures.
